# *Green Valley Inspections*

## Commercial Inspection Report

1234 Main St, Your Town, CA 92333  
Inspection prepared for: John Smith  
Date of Inspection: 4/10/2013 Time: 10:00AM  
Age of Home: 1996 Size: 9899  
Weather: Clear

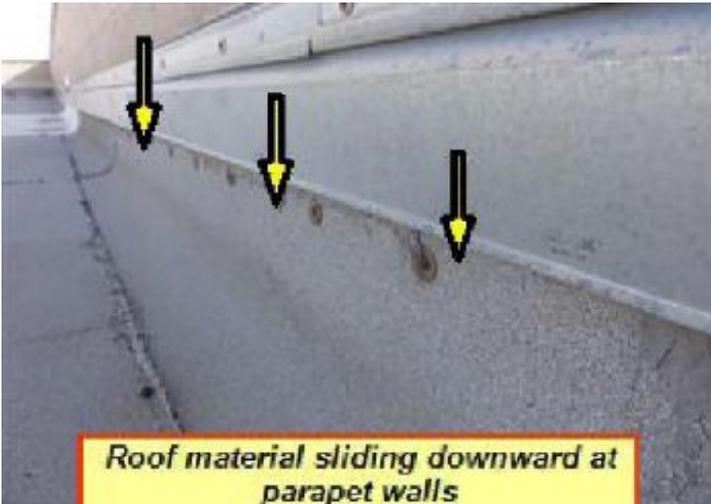
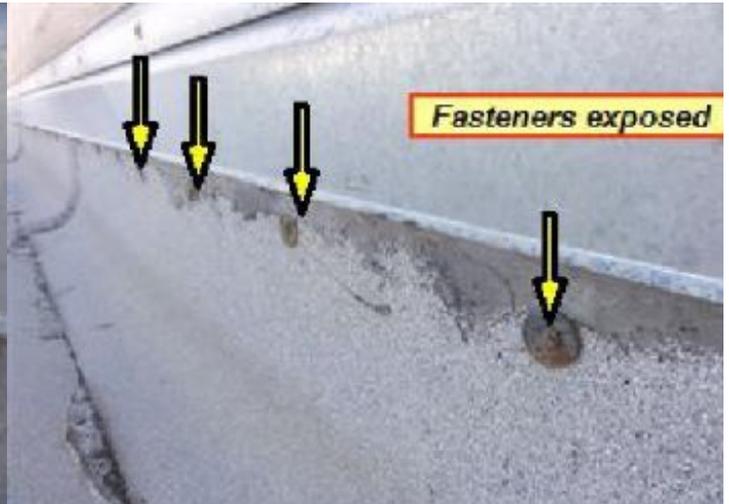
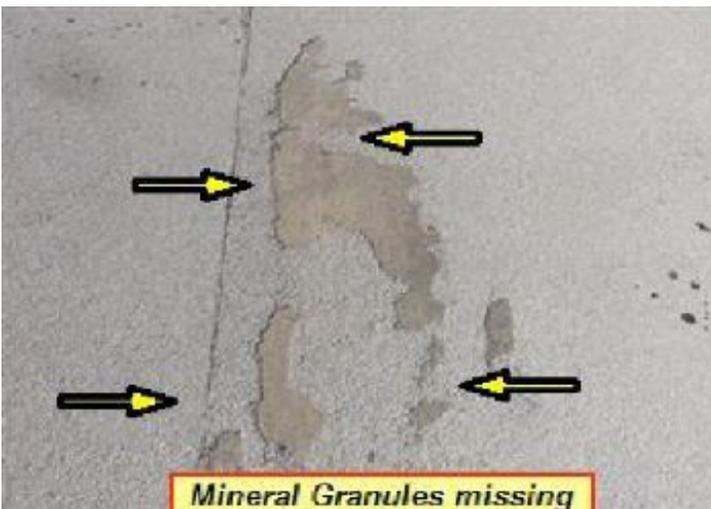
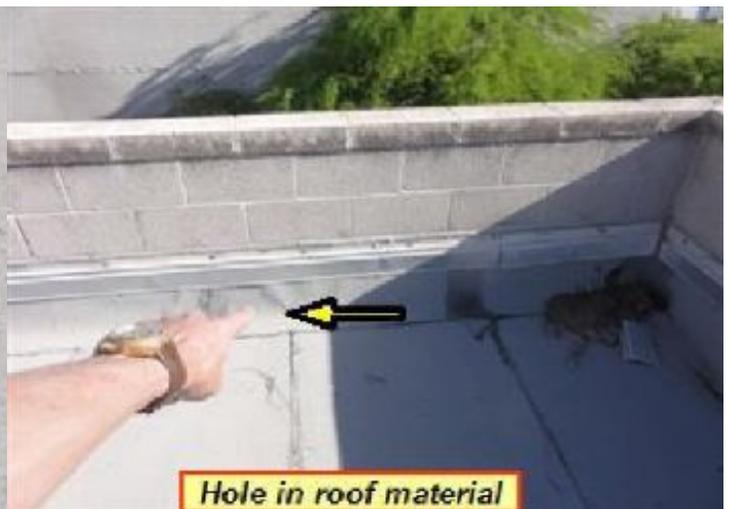
## 1. Roof Covering

- the material is in normal condition over most of the roof surface but several repairs are needed. The material is shrinking from age-sun exposure, the modified bitumen is sliding downward from beneath the metal side-wall flashing at parapet walls. More roof material should be installed around the entire roof perimeter or water will eventually begin leaking at the base of the parapets.

There is a hole in the roof material at the northeast side of the roof, the material needs to be repaired at this location to.

The is a large area the mineral granules are missing from the roof material at the southeast. Water leaks at the roof drains, I could see water stains inside the building at interior walls and below roof drain at the west.

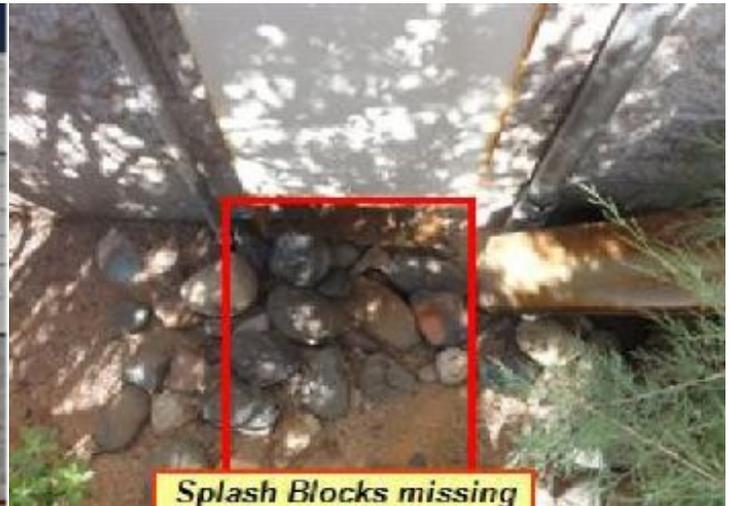
### 4. Downspouts

- Roof scupper and downspout needs repair and replacement

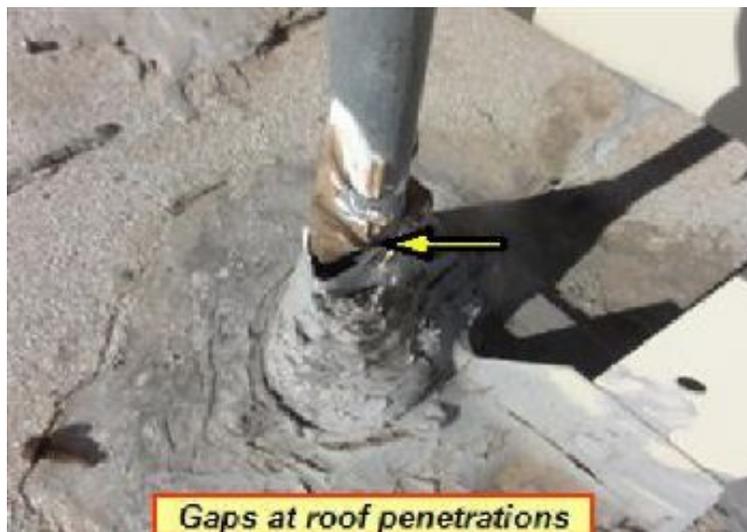
### 5. Vents, Flashings, Skylights, Chimney and other Roof Penetrations

- All roof penetration need to be sealed, plumbing vent, conduits, skylights, etc. There is a crack at the roof drain at the southwest portion of the roof. The roof material should be replaced at all roof drains.

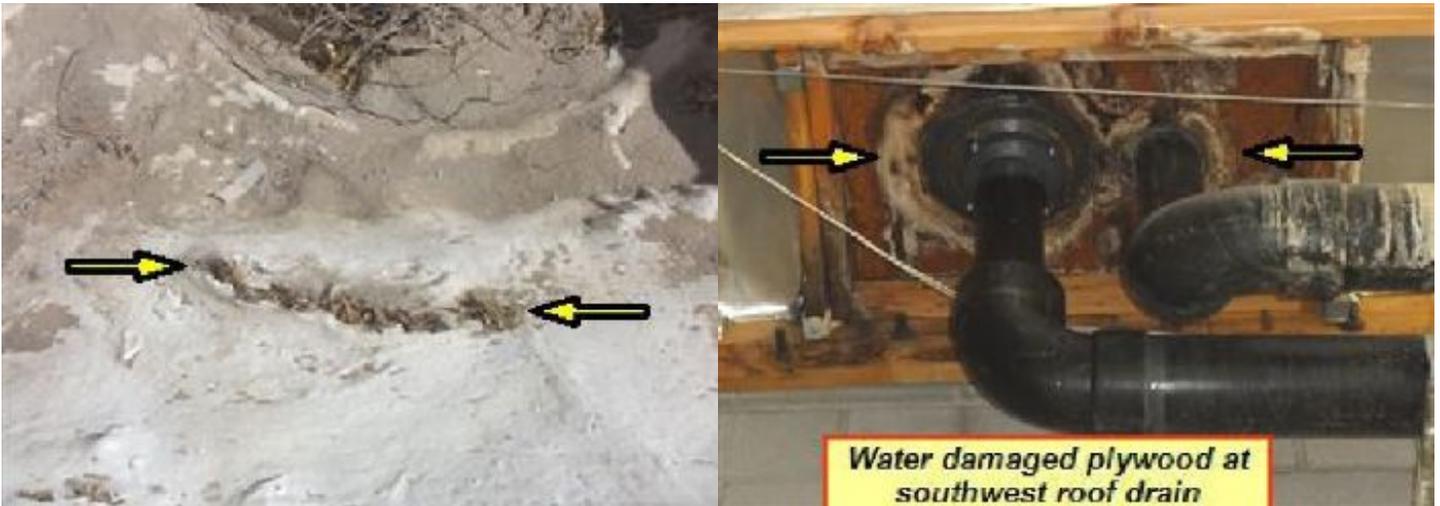
### 7. Leaks

- Both roof drains are in need or repair. Damage to roof material.

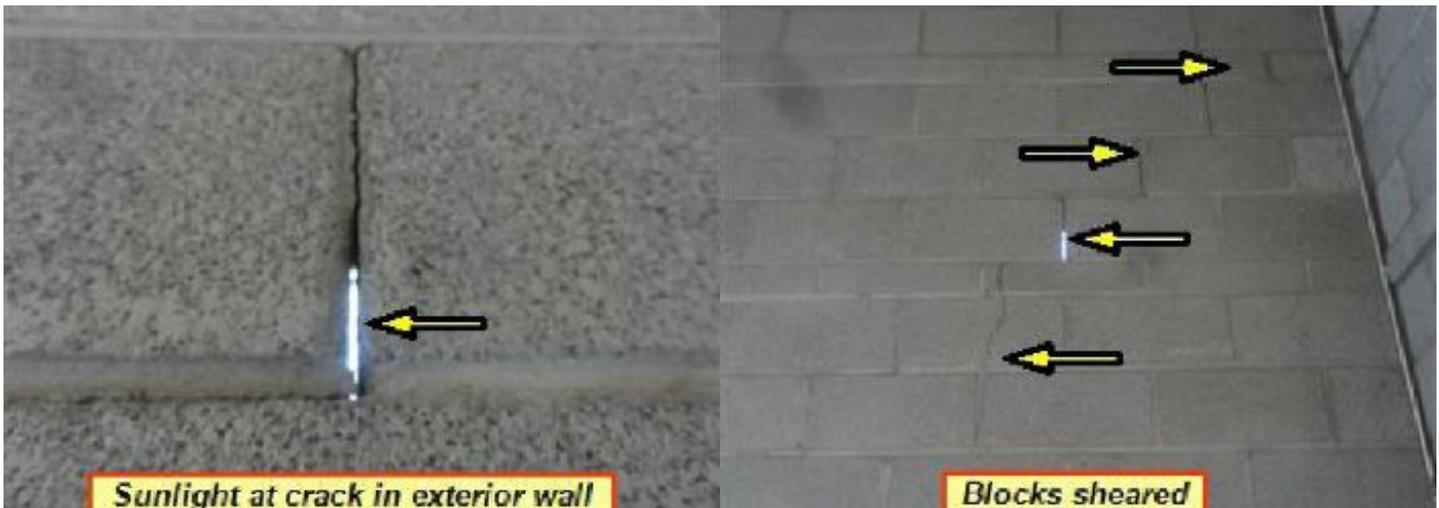
### 1. Siding, Flashing and Trim

- There are several cracks in the blocks, some through the center of blocks, others following mortar joints. I could see sunlight from inside the building looking outward at the south wall. You should have a structural engineer review the masonry walls and design a repair method to help eliminate further cracking or wall failure.

- There are open cracks in mortar joints, blocks sheared in half and step cracks. Have a licensed masonry contractor or structural engineer review the masonry walls before your inspection contingency period ends.

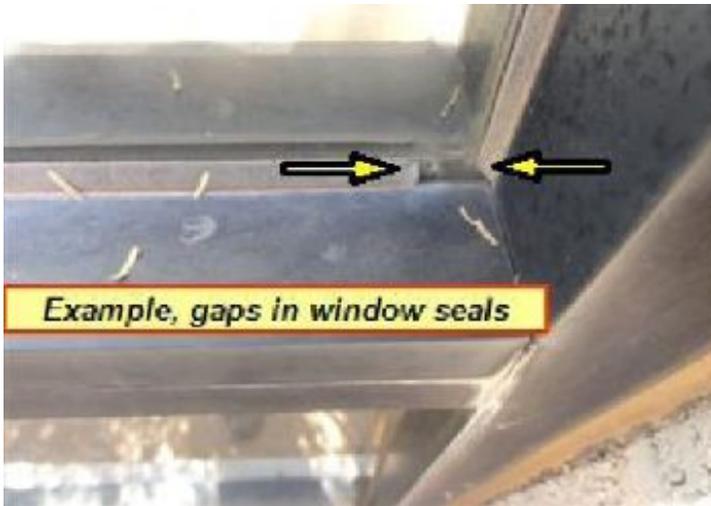
- The rubber window seals installed where the glass meets the frames have shrunk from age sun-exposure, I could see water stains at the interior frames. Have a commercial glass contractor replace all deteriorated window seals. There are gaps at the window frames where the windows meet the walls, new caulk is needed.

Example, gaps in window seals

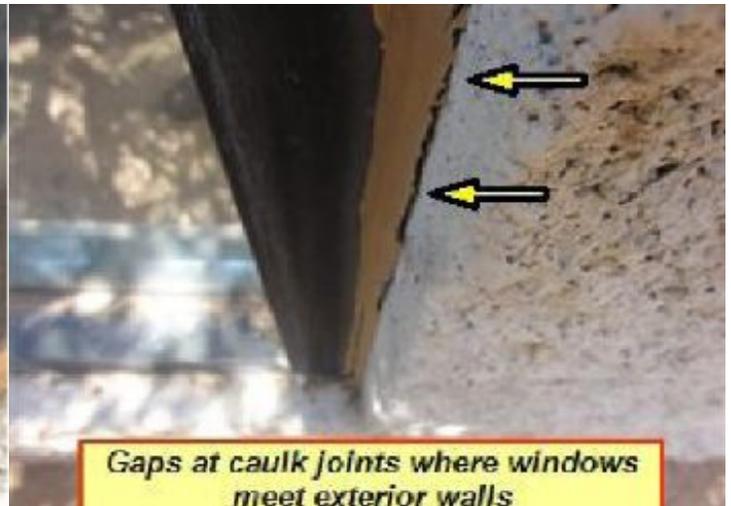
Gaps at caulk joints where windows meet exterior walls

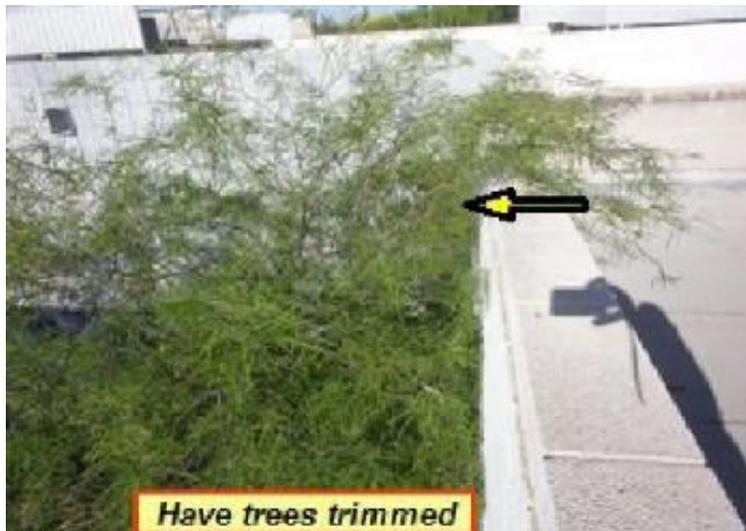
- Trees should be trimmed back away from the structure.

Have trees trimmed

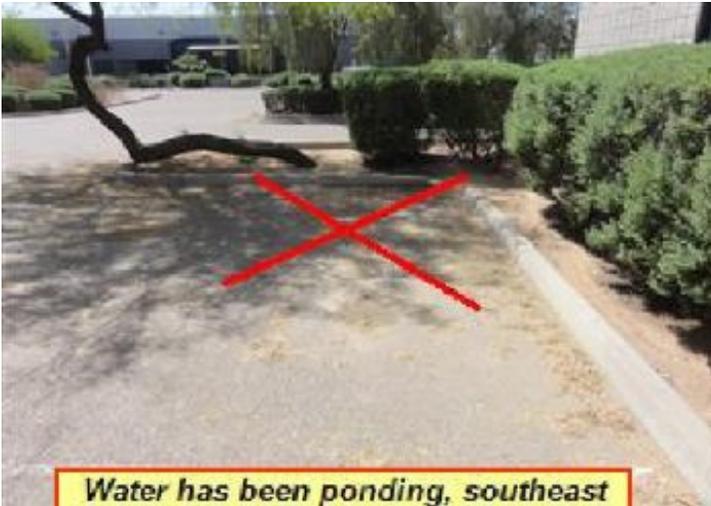
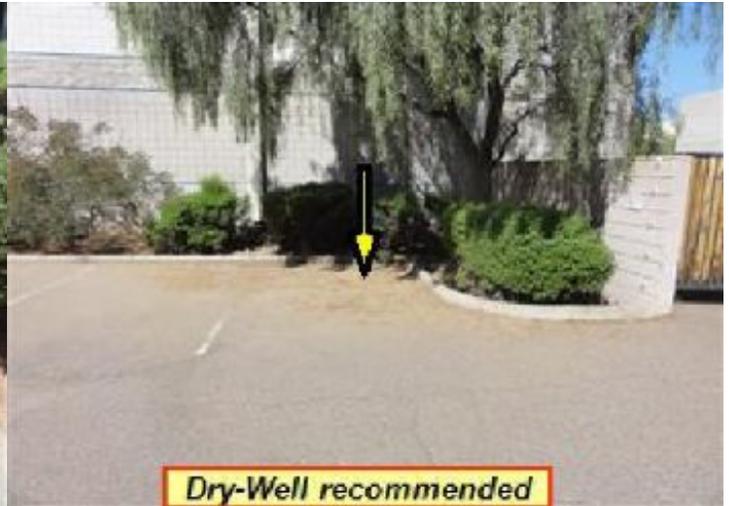
7. Storm Water Drainage System

- Water ponds at the northeast and southeast portion of the property. When the site was designed the architect didn't take into consideration the water has no place to flow from the east, you should consider having a dry-well(s) installed so water is not ponding in the future.

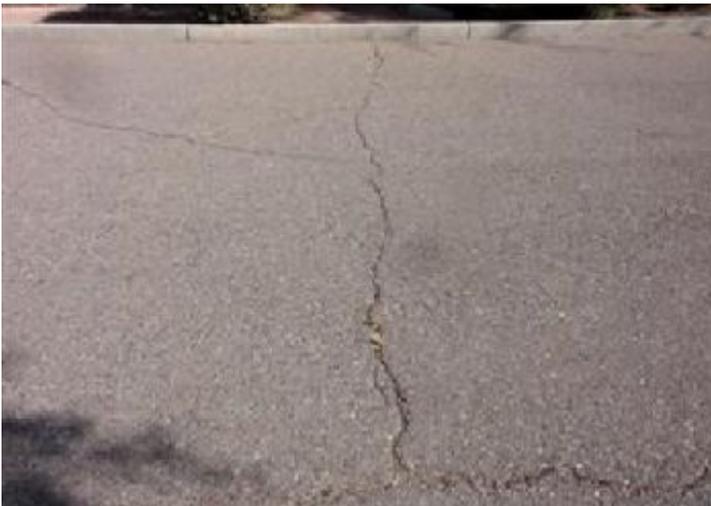
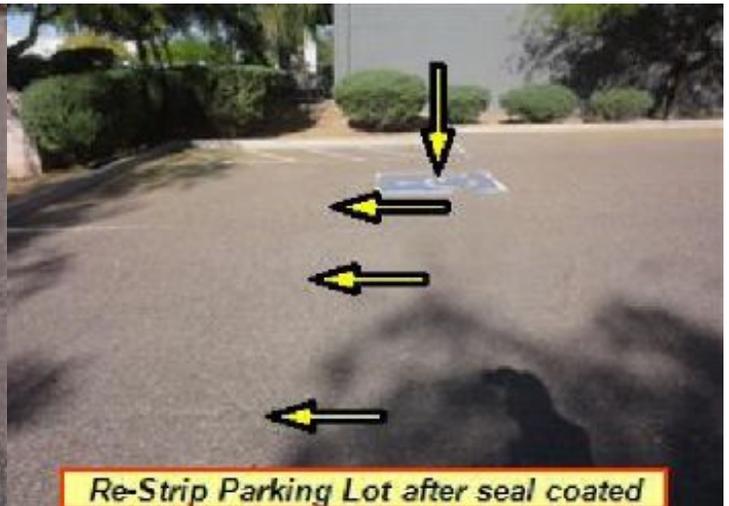
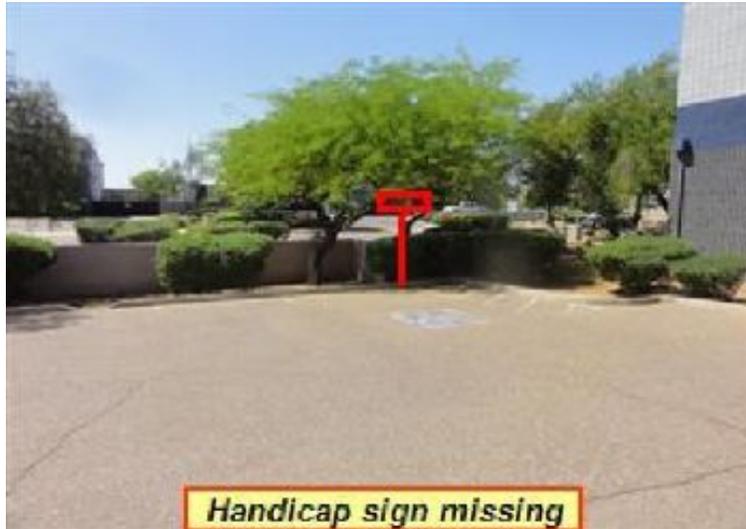
### 8. Parking Areas

- You should have all cracks in the asphalt sealed with tar, then have the surface seal-coated to stop further deterioration.
- The asphalt is cracking due to age, the striping is deteriorated, the handicap parking label is not clearly identified.

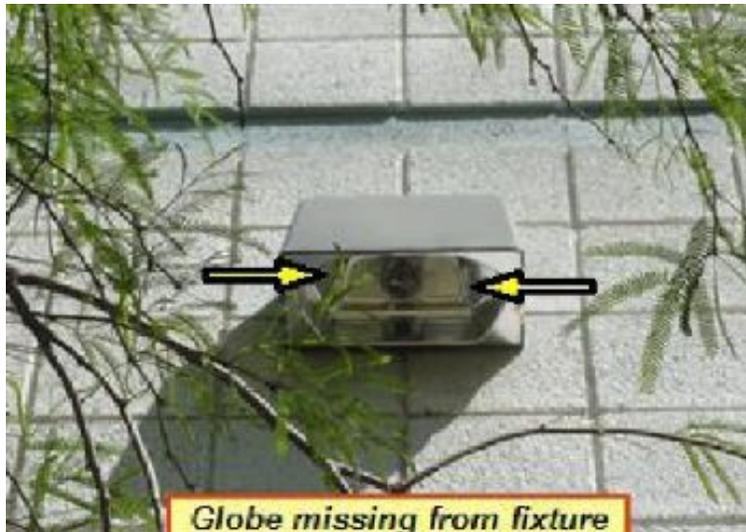
9. Lighting

- The electricity was off at the time of this inspection, I could see a front exterior light with the light- globe missing, the other lights have deteriorated globes from sun exposure. Whether the lights function is unknown

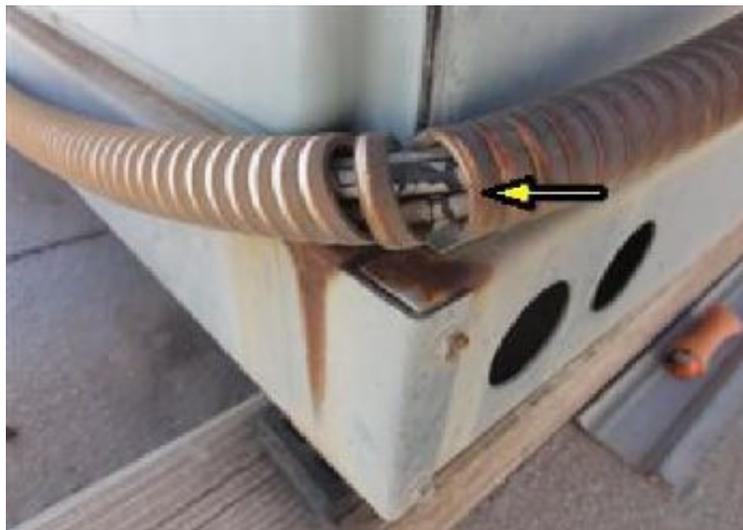
## 7. Connector Damage

- Flexible conduit has failed and should be replaced

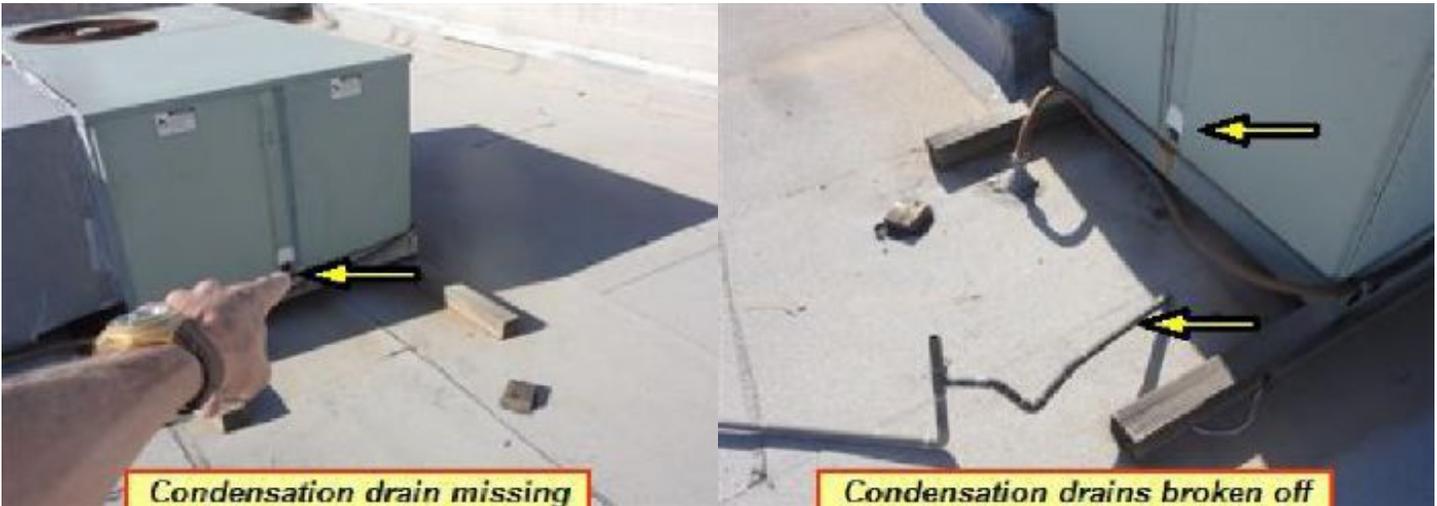
### 9. Condensate Drains

- Condensate drain lines are missing off of one and not connected on the other

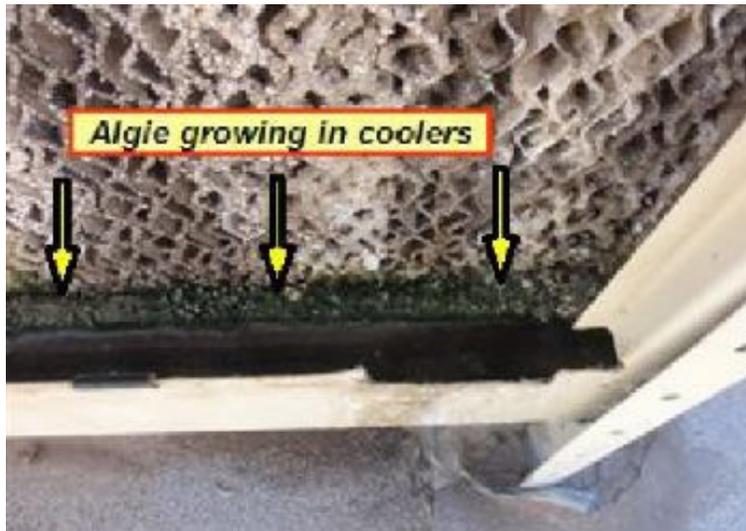
## 3. Condition

- **Recommend service on swamp coolers. algae noted on filters**

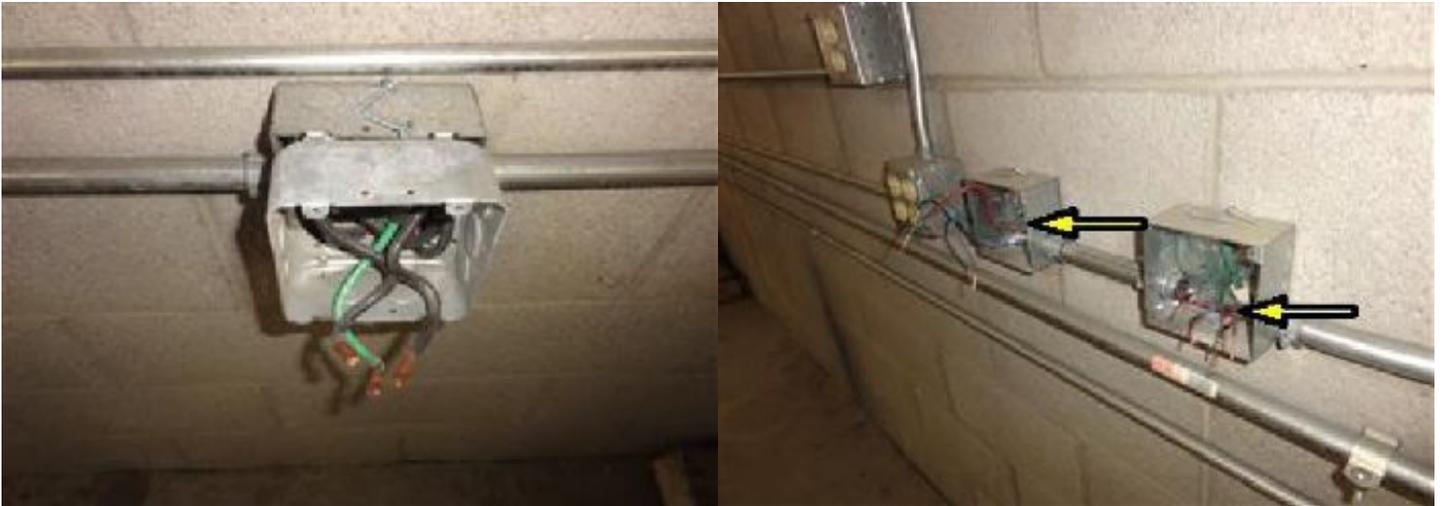
## 10. Missing Covers

Observations:  
 • Missing receptacle and covers, exposed wiring, recommend repair.

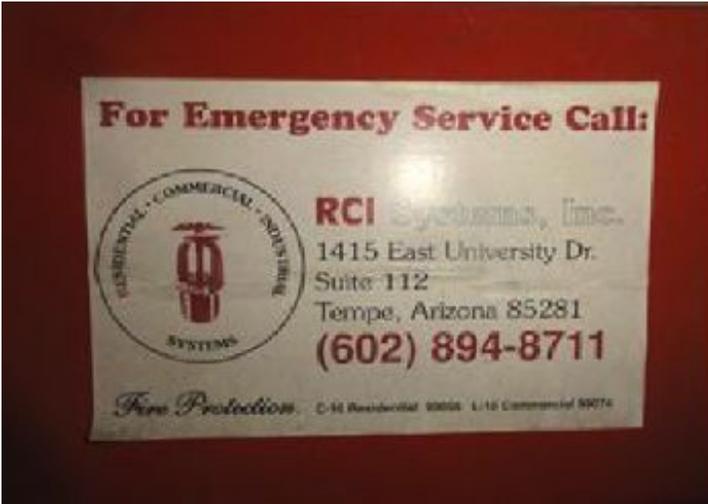
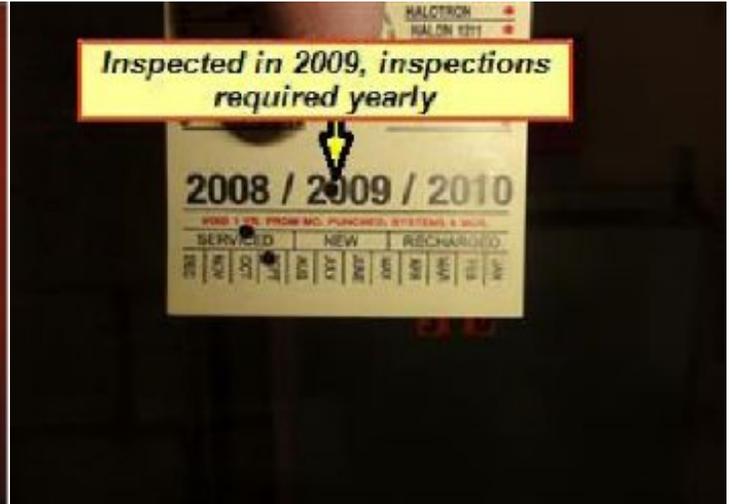
## 1. Fire Alarm Systems

- The fire suppression system has not been inspected since 2009, I suggest contacting the alarm company who is monitoring the system, attached with photos is their contact information
